ProTek Inspections Inc.

123 Easy Street
Kalamazoo, MI 49009

Prepared for: Savvy Buyer

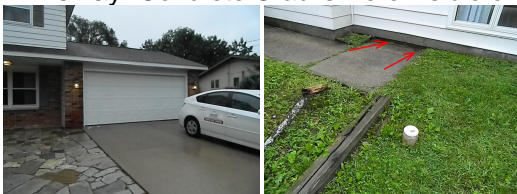
1. Acceptable Driveway: Concrete Cracks were visible on the concrete surface.

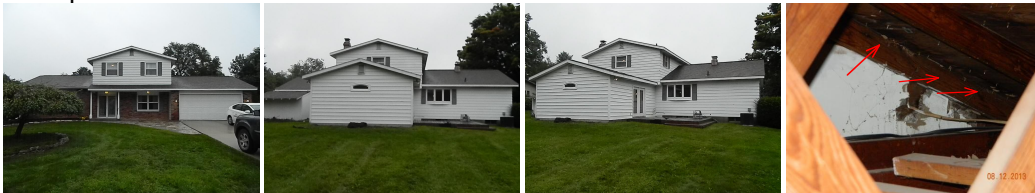
1. Acceptable Type: Aluminum and vinyl siding with brick veneer The siding is weathered from exposure, the aluminum has been painted.

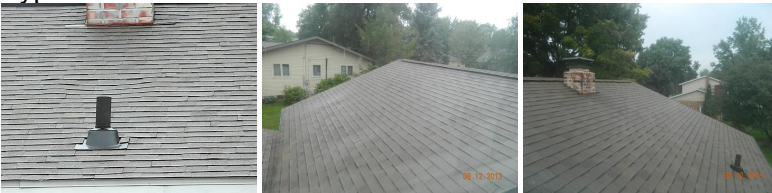
1. Method of Inspection: Ground level view with binoculars., Adjacent roof
2. Marginal Unable to Inspect: 25%. rain prevents walking the roof.
3. Marginal Material: Asphalt/composition laminated profile shingle The shingles reveal premature fine cracks and are delaminating mineral on the laminated face portion of the shingle. This condition is suspected to be a factory manufacturing defect but does not appear to have affected the weather resistance of the shingle. Forecasting future performance of the shingle is not possible. Similar conditions have been viewed on other homes inspected by this inspector.
Minor deflection observed in the plywood/roof plane suspected to be age related. Minor lifting observed in the shingles also; anticipate monitoring and maintenance.

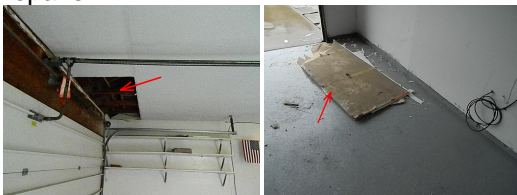
2. Marginal Ceiling: Gypsum board Damaged drywall observed at the overhead door. Bowing and delaminating drywall observed in multiple areas of the garage ceiling. Seams and tape are delaminating and have been repaired in some areas; anticipate repair as necessary. A qualified contractor is recommended to evaluate and estimate repairs

Ceiling: Estimated cost to replace the damaged drywall and glue and screw the delaminating drywall as necessary.

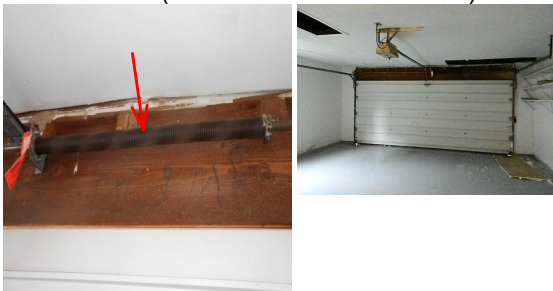
6. Defective Door Operation: Mechanized The torsion springs are not functioning as intended when the door is disconnected(the door does not station) from the opener and used manually adjustment or repair is necessary.

Door Operation: Estimate to repair/adjust garage door torsion springs

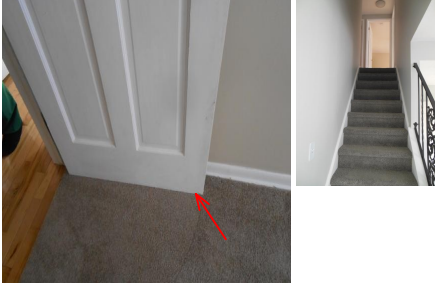
Doors: Hollow core wood composite Multiple door units require adjustment or repair: the northwest bedroom door rubs on the carpet, the 1/2 bath door will not latch. The dining room pocket doors are missing hardware and one side will not move (painted); repair is necessary.

Doors: Estimated allowance to repair the interior doors

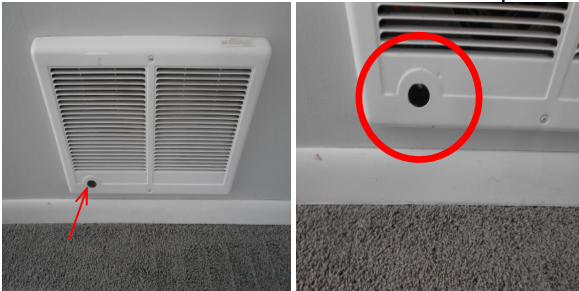
HVAC Source: Central heating metal duct system with register diffusers & return air grilles. Family room addition has two wall mounted electric heaters. The north unit was functional. The south unit has no control knob and could not be tested for function. Further evaluation is necessary. A qualified contractor is recommended to evaluate and estimate repairs

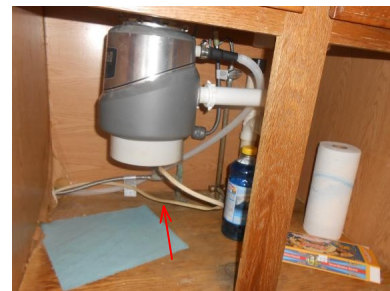
| 3. Defective | Disposal: Kenmore The unit is incorrectly "hard wired" with exposed Romex type wire. Disposals should be plug and cord connected to a switched outlet. Correction is necessary. |

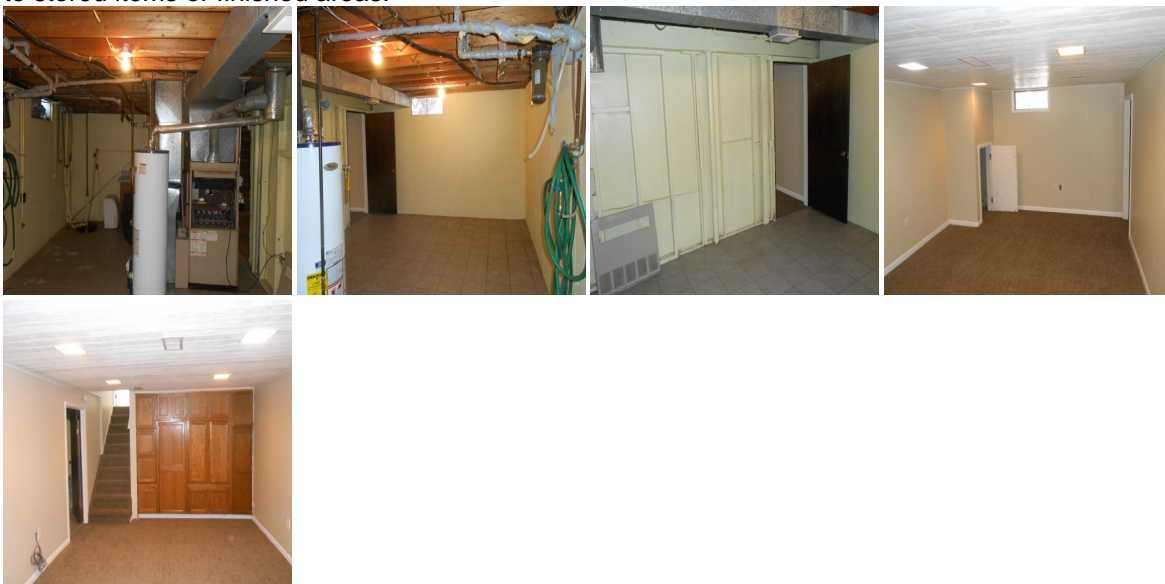
- 1. Acceptable Structure Type: Single family, wood frame w/poured concrete foundation
- 2. Acceptable Foundation: Poured concrete basement and slab All walls, frame and/or floor were not visible or inspected due to stored items or finished areas.

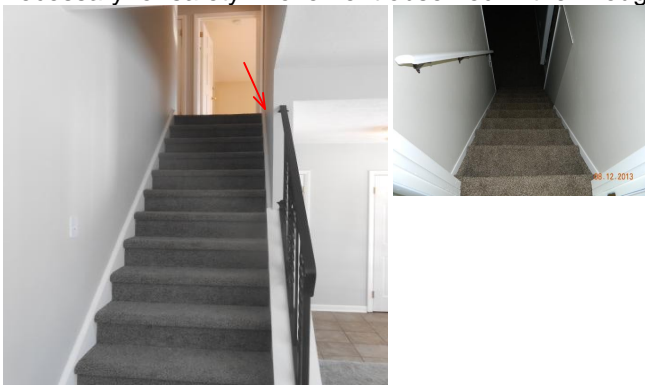
- 3. Not Present Differential Movement: No evidence of significant movement or displacement observed in the foundation walls as visible. Typical shrinkage cracks from curing observed.
- 4. Acceptable Beams: 2x10x3
- 5. Acceptable Bearing Walls: Wood framed and finished interior walls
- 6. Acceptable Joists/Trusses: 2x8's, 16" o.c.
- 7. Acceptable Piers/Posts: Steel columns
- 8. Acceptable Floor/Slab: Poured concrete
- 9. Acceptable Stairs (Interior): Wood stairs with wood handrails
- 10. Defective Railings: Wrought iron or simulated., Wood 2nd floor stair rail is not full stair length; corrective action is necessary for safety. Movement observed in the wrought iron guard rails.

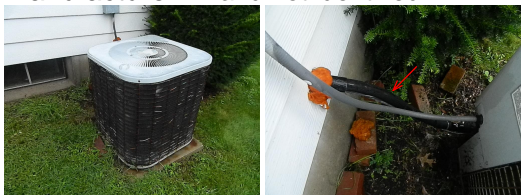
- 1. Marginal A/C System Operation: The A/C unit responded to thermostat call. The unit is in service beyond the manufacturer's stated design life of 14-16 years. Due to the new EPA SEER requirements the entire cooling system: compressor, refrigeration piping and evaporator coil will require replacement; anticipate updating (\$3000).
- 2. Acceptable Condensate Removal: PVC piping and electric pump
- 3. Marginal Exterior Unit: Pad mounted The exterior compressor coil fins are minimally visible to inspection.
- 4. Manufacturer: Brand not identified.

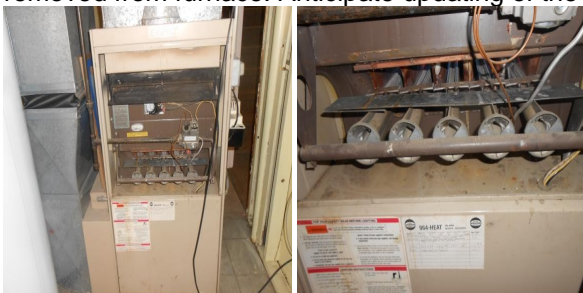
1. Marginal Heating System Operation: Unit responded to thermostat call The furnace is in service beyond the manufacturer's suggested life cycle of 15-20 years. This age, type and model of furnace has a history of premature heat exchanger failure due to design flaws. This damage cannot be verified unless heat exchanger is removed from furnace. Anticipate updating of the furnace in the very near future(\$3000-\$3200).

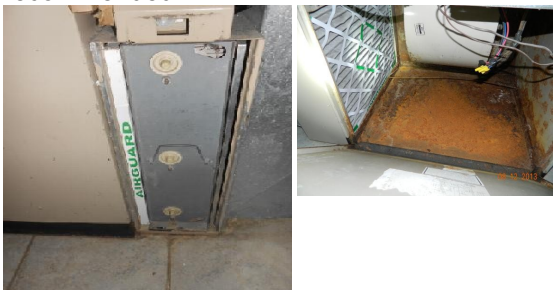
7. Unable to Inspect: Heat exchanger evaluation is outside the scope of this inspection
8. Defective Blower Fan/Filter: Direct drive with electronic air cleaner and disposable filter. The electronic air filter is not in service. The media air filter is not a box type filter and may be sucked into the blower fan. A box type filter is recommended.

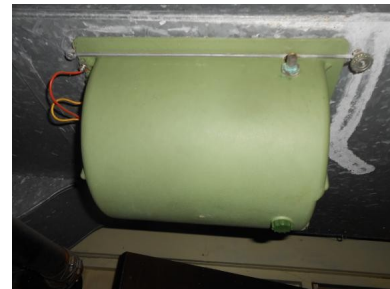
13. Defective Humidifier: General Filter Unit is disconnected and no longer in service; suggest removal and sealing duct work and installing a new unit.

Humidifier: Estimated cost to replace the humidifier	\$ 450	\$ 500
--	--------	--------

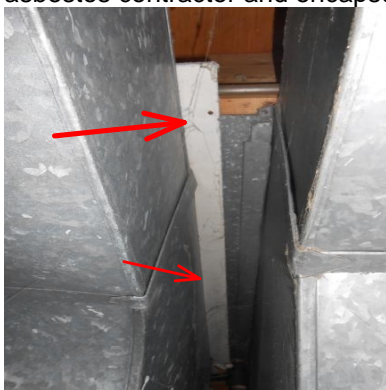
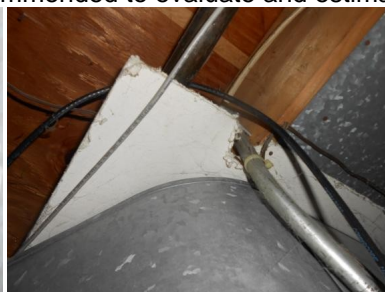
Asbestos resembling insulation board was observed above the furnace in the basement. Recommend evaluation by a certified asbestos contractor and encapsulation as necessary. A qualified contractor is recommended to evaluate and estimate repairs

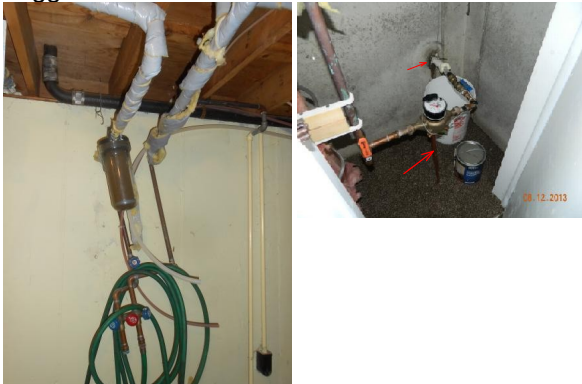
3. Not Inspected Water Lines: Copper No water supply; no evaluation with testing was possible.
Pipes lack adequate support where softener was removed and pipe support is broken at laundry; repair is suggested.

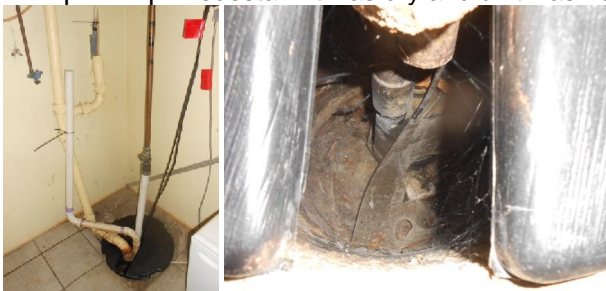
11. Not Inspected Plumbing/Fixtures: Chrome fixtures with copper, stainless, pex or butylene connectors and pvc or vinyl drain piping. No water supply; no evaluation with testing was possible.
12. Not Inspected Sump Pump: Pedestal Pit was dry and unit was not tested or operated; suggest further evaluation.

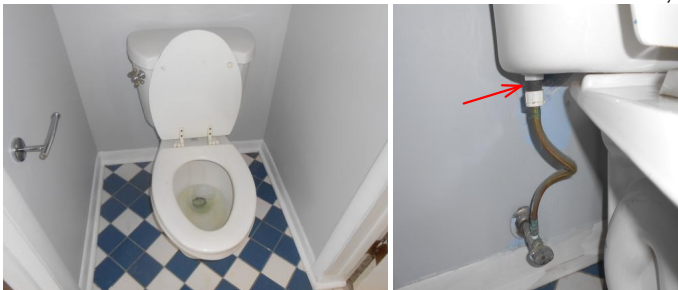
14. Defective Toilets: 1.6 Gal. tanks The 1/2 bath unit leaks from tank; repair necessary.

Toilets: Estimated cost to repair the toilet leak at the 1/2 bath.

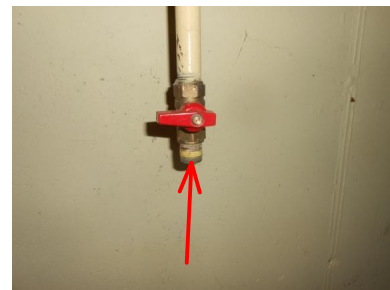
23. Acceptable Gas Meter: Exterior surface mount at side of home
24. Acceptable Main Gas Valve: Located at gas meter
25. Acceptable Gas Service Line: Steel
26. Marginal Dryer Gas Line: Black iron pipe The dryer gas line is open and not capped; hazardous. Immediate capping is recommended if a gas dryer is not installed.

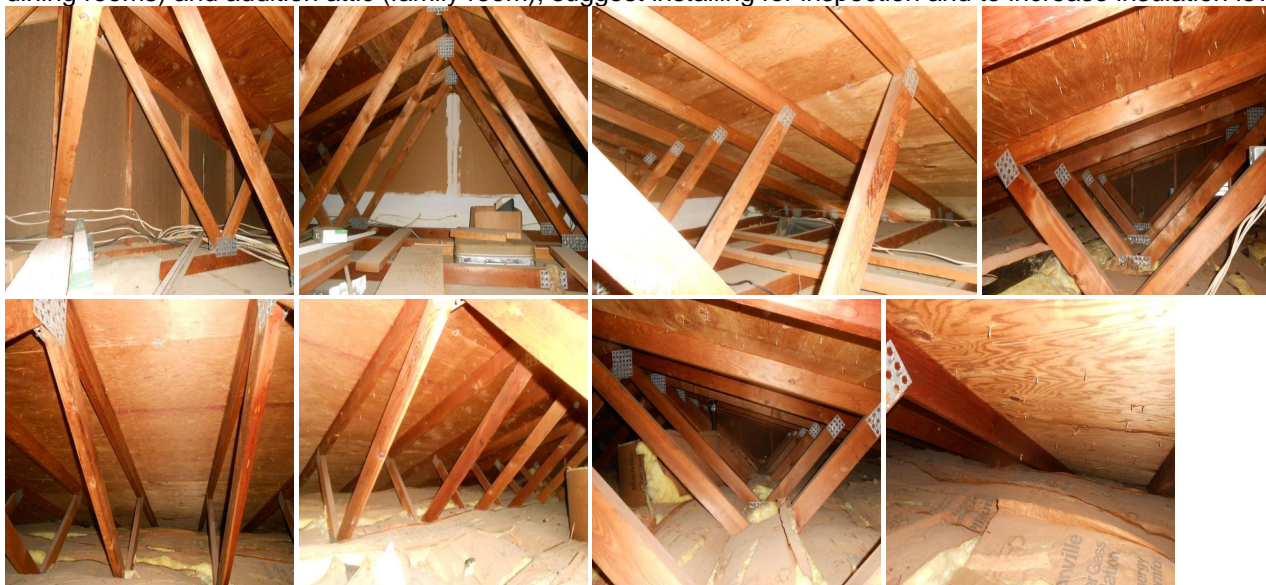
2. Marginal Unable to Inspect: 50% of the attic space was not accessible No visible attic access for north attic (living and dining rooms) and addition attic (family room); suggest installing for inspection and to increase insulation levels.

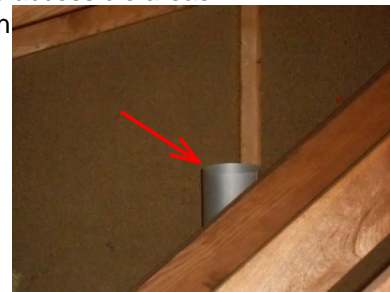
9. Defective Bathroom Fan Venting: Bathroom exhaust fans terminate in the attic and can contribute to moisture and potential for mold in the attic. Recommend extending bathroom fan ducts to exterior with insulated ducting.
