ProTek Inspections Inc.

1212 Street Ave.
Kalamazoo, Michigan

Prepared for: Your Client

Prepared by: ProTek Inspections Inc.
5047 West Main Street #405
Kalamazoo, MI 49009
Inspector: Janis Putelis, ACI

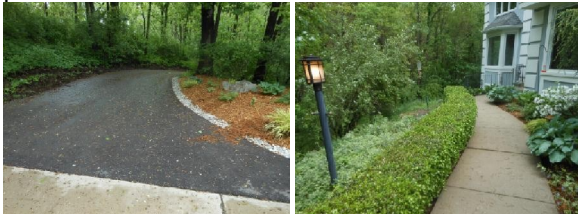
Driveway: Concrete, Asphalt Installation of water runoff spillway will help control the erosion of soil at the perimeter of the drive down the hill.

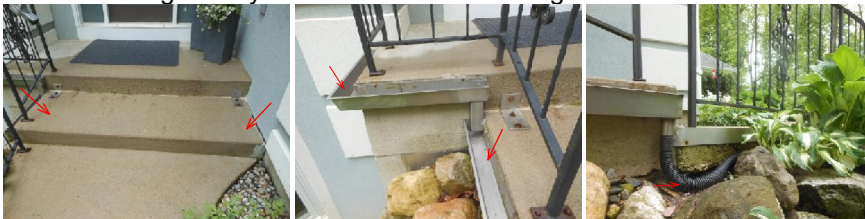
Stoops: Concrete The front stoop step has settled approximately one inch. The settling is suspected to be from inadequate substrate compaction and roof water runoff. The stainless steel water collection troughs installed on the front porch are suspected to be needed due to excessive water flow over the roof gutter system due to gutter screens. Removal of the screens is suggested to mitigate the excessive water flow. Portions of the stainless trough's vinyl drains are rodent damaged.

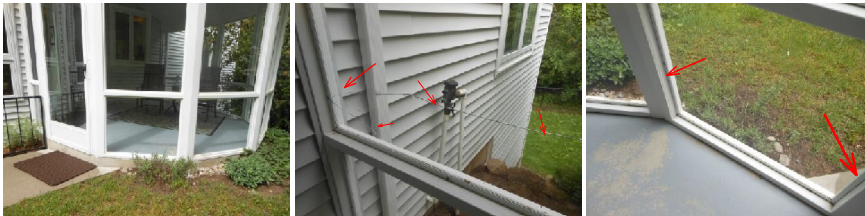
Screened Porch: Rear sun porch. Wood frame, glass in frames; cracked glass on the east elevation, replacement is necessary. No tempering labels observed on the glass. Further evaluation is necessary. Evidence of water leaks observed on the wood trim suspected to be during winter. Monitoring is recommended. Concrete floor.

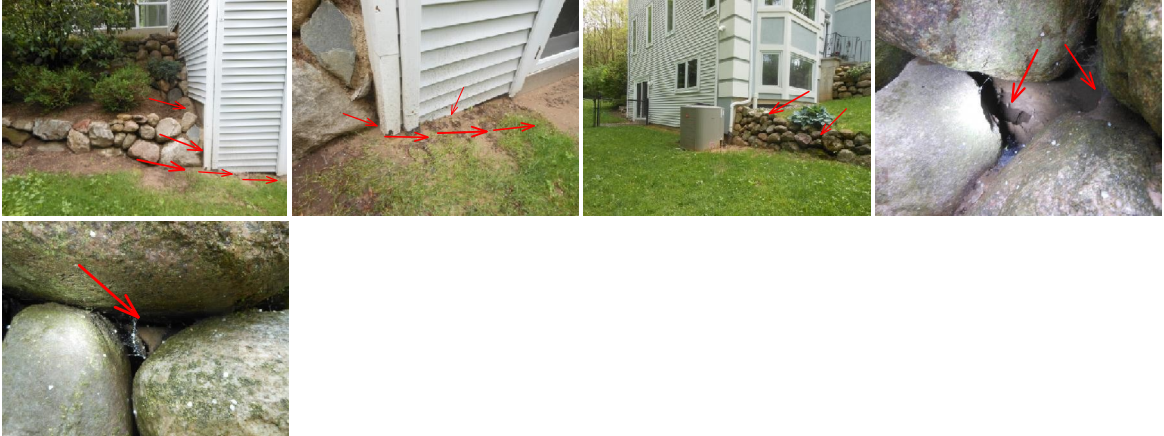
Retaining Walls: (continued)

Retaining Walls: Loose laid field stones. Substantial soil displacement was noted at the base of the retaining walls. No drainage provisions observed, silt filter noted however runoff water from higher elevations has eroded the base of the lower south and north walls. Rebuilding of the north wall will be necessary to correct including installation of drainage provisions, silt filter and compacted back fill. Additionally, removal of the gutter screens is recommended as this blocks the gutters and creates gutter overflow discharging on the grade.

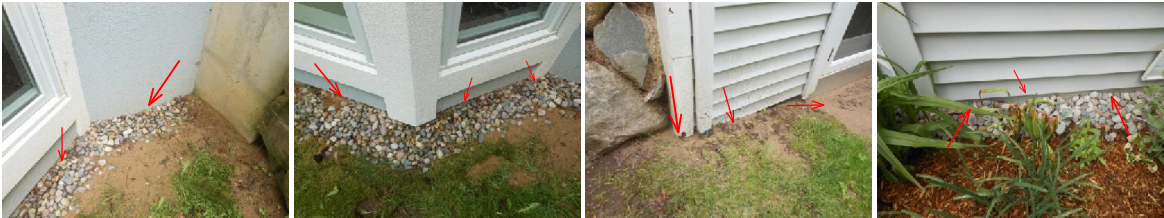
Grading: Banked with terraces on the north and south elevations leading to the walkout on the east. Anticipate grade adjustment to direct water away from the foundation on the east, west and south elevations. Soil should not be in contact with the vinyl siding or synthetic stucco. Corrective action recommended when the retaining walls are rebuilt.

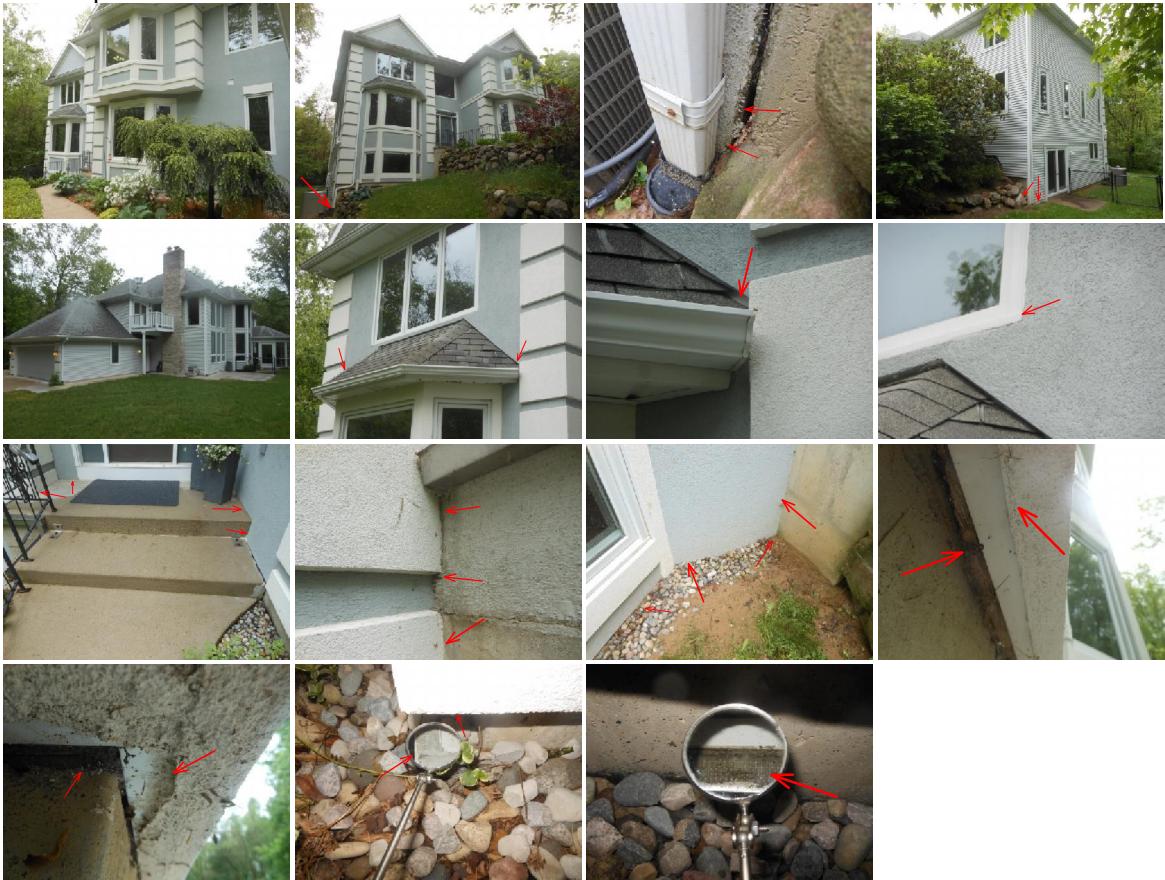
Several of the noted conditions were observed on this home.

EIFS exterior finishes are prone to water infiltration and may cause hidden damage to the structure. There was no visible evidence of such damage at this time. If further evaluation is desired the services of a qualified specialist is necessary. Presently we observed one location where the EIFS product has detached and is damaged (lower NE corner at the stone retaining wall). The stone retaining wall must be repaired prior to the EIFS repair.

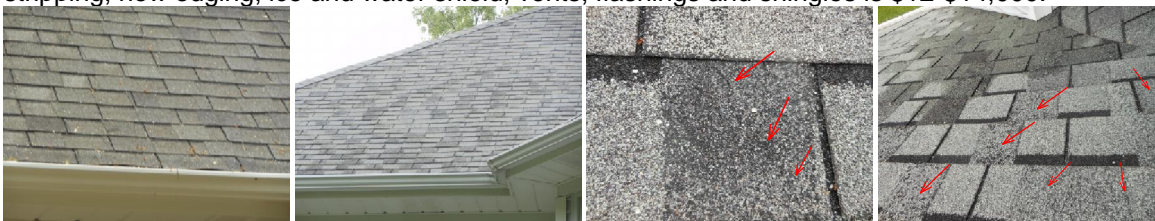
1. Method of Inspection: Ground level view with binoculars.
2. Marginal Unable to Inspect: 40% The east elevation roofing was not visible to inspection. Anticipate replacement of the sewer vent gasket on this elevation.
3. Marginal Material: Asphalt/composition shingle, Laminated profile Shingles reveal heavy mineral de-granulation on the laminated portion of the shingle relative to age and exposure. The surface cracks observed on the laminated portion of the shingle are suspected to be specific to a manufacturing defect. This condition appears to have deteriorated the granular surface the shingles; in our opinion this condition will minimally affect the longevity of the material given the current age of 18 years. Estimated cost to replace the shingles when necessary, including stripping, new edging, ice and water shield, vents, flashings and shingles is \$12-\$14,000.

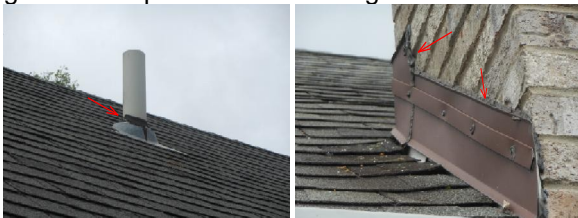
4. Type: Hip and gable combination.
5. Approximate Age: 18 years of anticipated 20-25 year life cycle.
6. Acceptable Flashing: Metal, Unknown Visible flashings are functional as viewed except for the missing kick outs at the EIFS; multiple flashing areas are covered and not visible. Caulking the counter flashing a the chimney will necessary.
7. Acceptable Valleys: Asphalt shingle, closed lap.
8. Defective Plumbing Vents: PVC with neoprene flashing gasket Damaged gasket on the visible unit, both sewer vent gaskets suspected to be damaged.

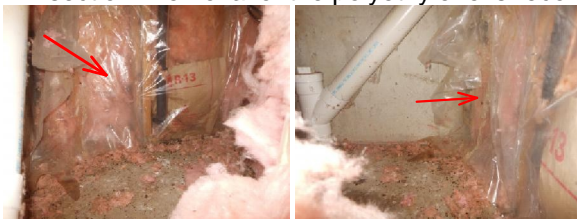
7. Marginal Vapor Barrier: Kraft paper on the fiberglass insulation., Polyethylene observed behind the finished wall in the NE section. Removal of the polyethylene is recommended if accessible.

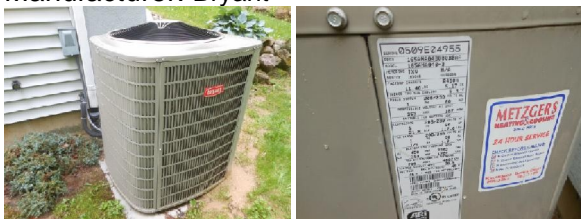
1. Acceptable A/C System Operation: The A/C unit responded to thermostat call.
2. Acceptable Condensate Removal: PVC piping
3. Acceptable Exterior Coil, Refrigeration Lines: Pad mounted with high and low pressure lines, insulation intact. The cabinet is in serviceable condition. The exterior coil fins are dirty and should be cleaned.
4. Manufacturer: Bryant

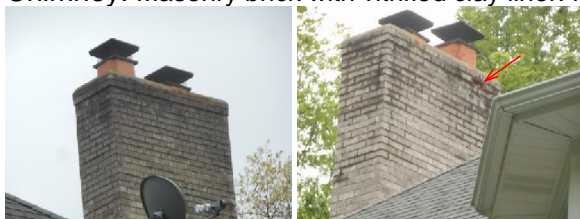
12. Marginal Chimney: Masonry brick with vitrified clay liner. Minor brick damage observed below the cap; anticipate repair.

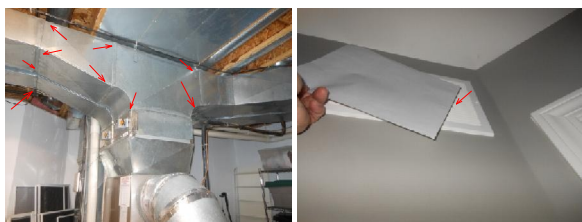
9. Marginal Distribution: Metal duct with wood & metal panned returns Minimal or lower air intake flow observed on the upper floor return air grilles.

Multiple leaks were noted in the supply and return system at the plenums adjacent to the furnace in the basement. Sealing these openings will increase efficiency of operation and lower energy costs.

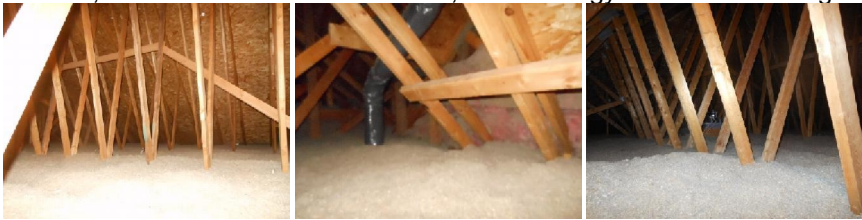
Insulation and Depth: 8-10' R-30 to R-36 The insulation depth varies as observed. Standard requirement of insulation was R-30, 8 " for cellulose, blown in when the home was built. Adding 6-8" of cellulose will increase comfort, decrease conditioned air loss, lower energy bills also lowering the carbon footprint of the home.
