ProTek Inspections Inc.

123 Easy Street
Kalamazoo, MI 49009

Prepared for: Savvy Buyer

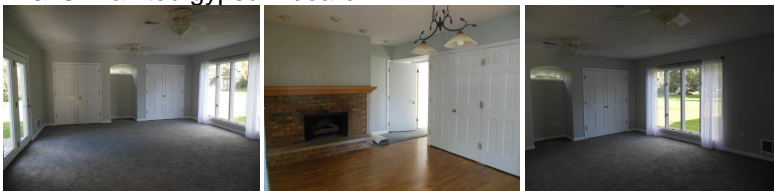
3. Acceptable Walls: Painted gypsum board

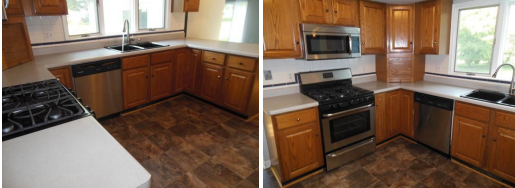
Kitchen Cabinets: Wood and composite materials

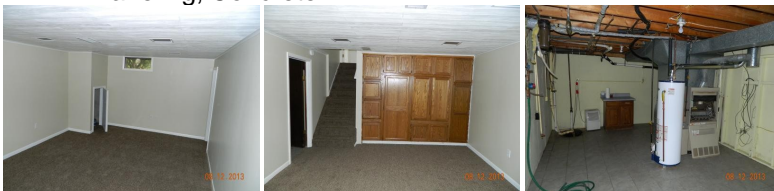
- 1. Acceptable Unable to Inspect: All areas are visible to inspection except where covered by finished walls, ceilings, floor coverings, insulation and where storage items block view.
- 2. Acceptable Ceiling: Paneling, Exposed framing
- 3. Acceptable Walls: Paneling, Concrete

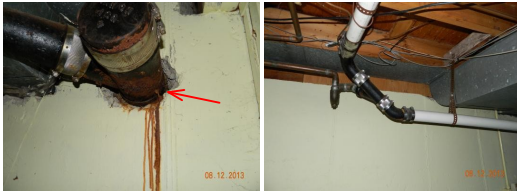
4. Acceptable Vent Pipes: Cast iron Not all vent pipes are visible to view or inspection.
5. Acceptable Basement Floor Drain: Grate in concrete floor

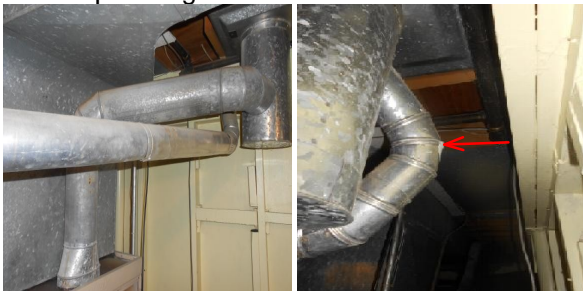
15. Not Inspected Water Heater Operation: Functional at time of inspection No water supply, no gas on. Further evaluation is recommended when water is on.
16. Manufacturer: US Craftmaster, Whirlpool
17. Type: Natural gas Capacity: 40 Gal.
18. Approximate Age: 2 years or less Area Served: Entire house
19. Acceptable Flue Pipe: Single wall metal vent
