ProTek Inspections Inc.

1212 Street Ave.
Kalamazoo, Michigan

Prepared for: Your Client

Prepared by: ProTek Inspections Inc.
5047 West Main Street #405
Kalamazoo, MI 49009
Inspector: Janis Putelis, ACI

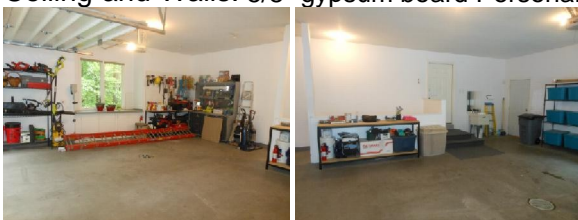
- 1. Type of Structure: Wood frame, attached. Car Spaces: 3
- 2. Acceptable Ceiling and Walls: 5/8" gypsum board Personal storage items block full view of the garage interior.

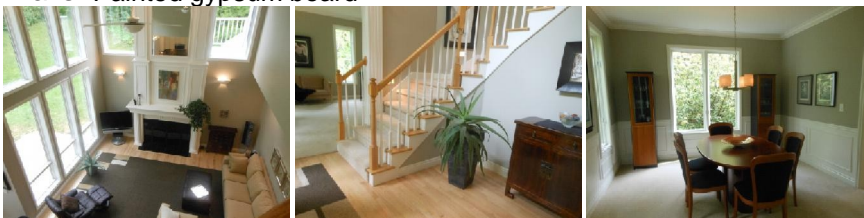
- 1. Acceptable Closets: Multiple closets, all bedrooms and hallways.
- 2. Acceptable Ceilings: Painted gypsum board
- 3. Acceptable Walls: Painted gypsum board

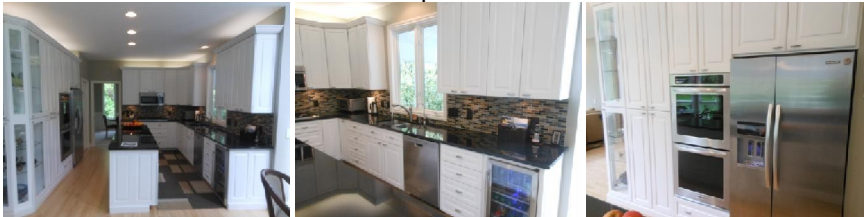
7. Acceptable Kitchen Cabinets: Wood and composite materials

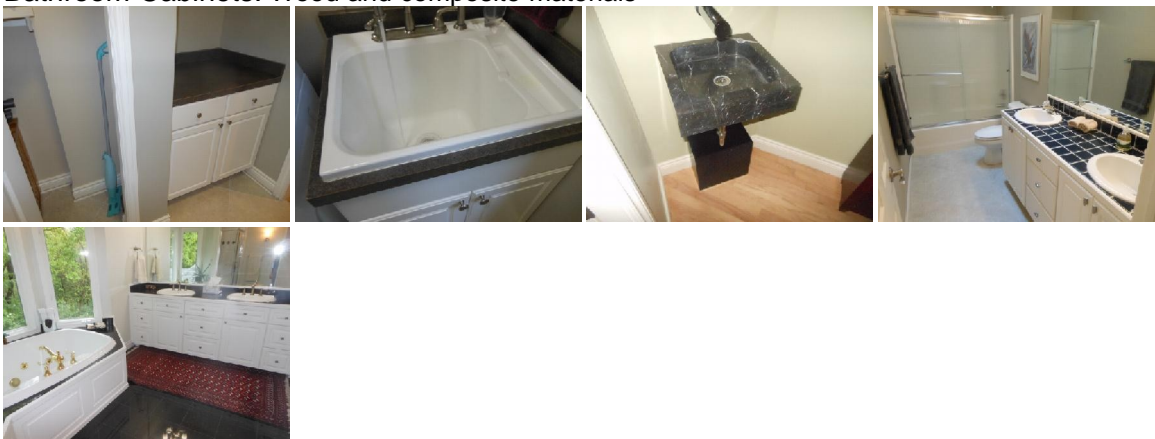
9. Acceptable Bathroom Cabinets: Wood and composite materials

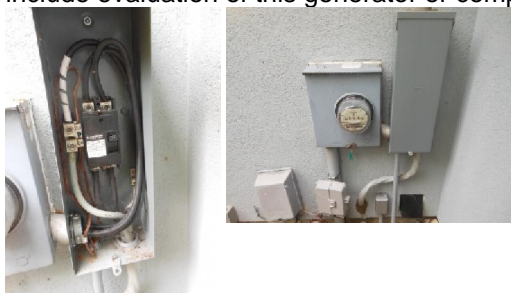
1. Acceptable Service Entrance: Under ground utilities
2. Service Size Amps: 200 Volts: 110-240 VAC
3. Acceptable Service: Copper #3, Aluminum, 4/0 The electrical main disconnect is located on the north elevation of the home's exterior. The service has an automatic engaging LP gas powered generator. This survey does not include evaluation of this generator or components.

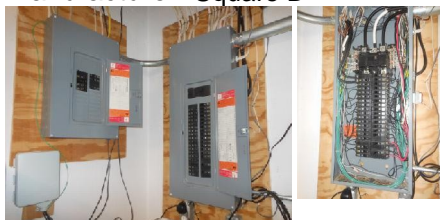
12. Acceptable Manufacturer: Square D

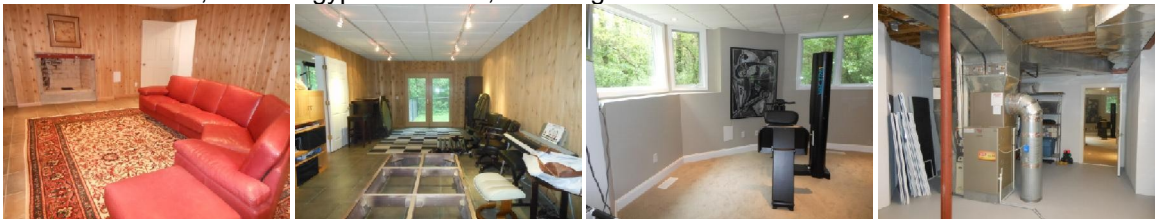
3. Acceptable Walls: Concrete, Painted gypsum board., Paneling

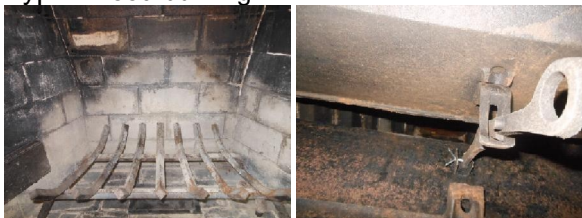
Family Room Fireplace

1. Acceptable Fireplace Construction: Masonry assembly. Masonry construction with gas log starter. Glass doors.
2. Type: Wood burning

3. Acceptable Smoke Chamber and Damper: Firebrick and masonry. The refractory is intact as visible and the damper is functional.
4. Acceptable Flue: Vitrified clay tile and masonry. Very limited view of flue, as viewed in the photo.
5. Acceptable Hearth: Floor level tile

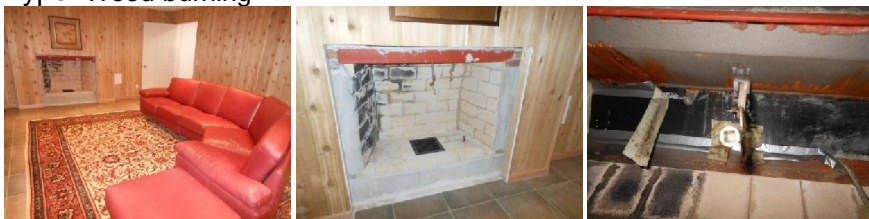
Basement Fireplace

6. Acceptable Fireplace Construction: Masonry assembly.
7. Type: Wood burning

8. Acceptable Smoke Chamber: Masonry firebrick The fireplace facade is not finished.
9. Not Inspected Flue: No flue observed.
10. Marginal Damper: Metal shutter. Tape closed.
11. Not Present Hearth:

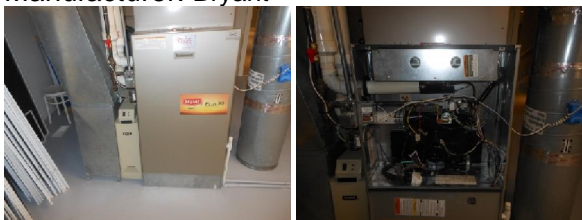
Basement Heating System

1. Acceptable Heating System Operation: Unit responded to thermostat call Anticipate a tune-up next season.
2. Manufacturer: Bryant

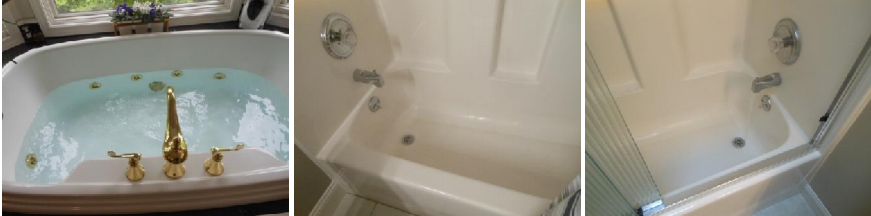
11. Not Present Sump Pump:
12. Acceptable Tub/Surround: Fiberglass tub and fiberglass surround
13. Acceptable Whirlpool Tub: Fiberglass tub with tile surround. Window glass surrounding the tub are tempered glass. The spa tub and GFCI are functional. No visible access to the spa motor was observed.
